# CT artifact masquerading as pathology involving basilar artery

Senthil Anbumani, M.D  
University of Kentucky

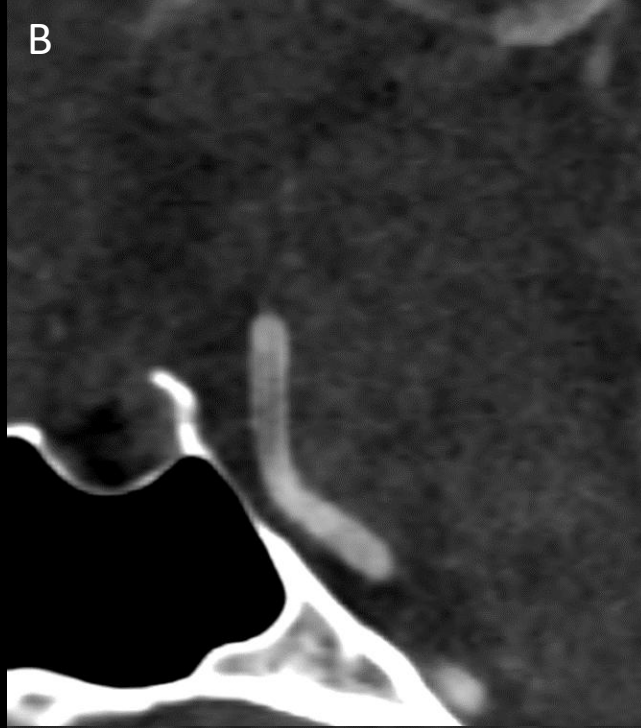
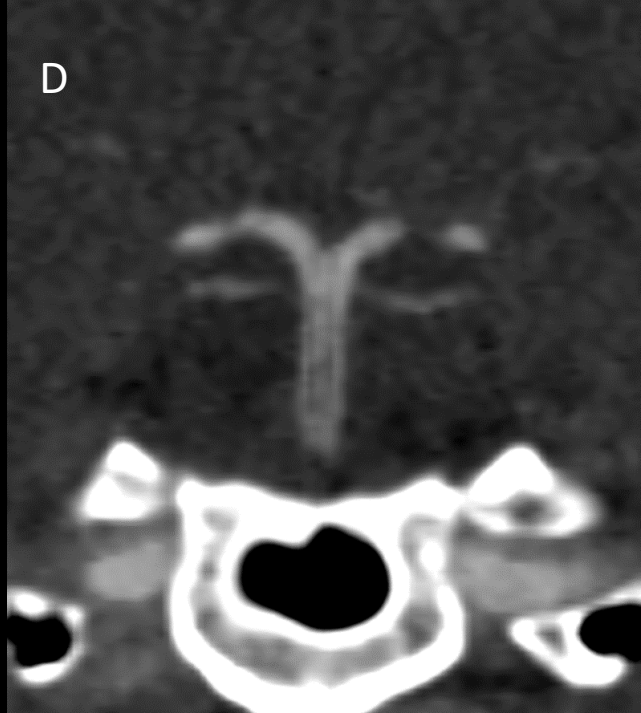
Low-density linear filling defect within the basilar artery in the sagittal (A) and coronal (C) reconstructions showing tram-track like appearance better appreciable in the zoomed-up sagittal (B) and coronal (D) images

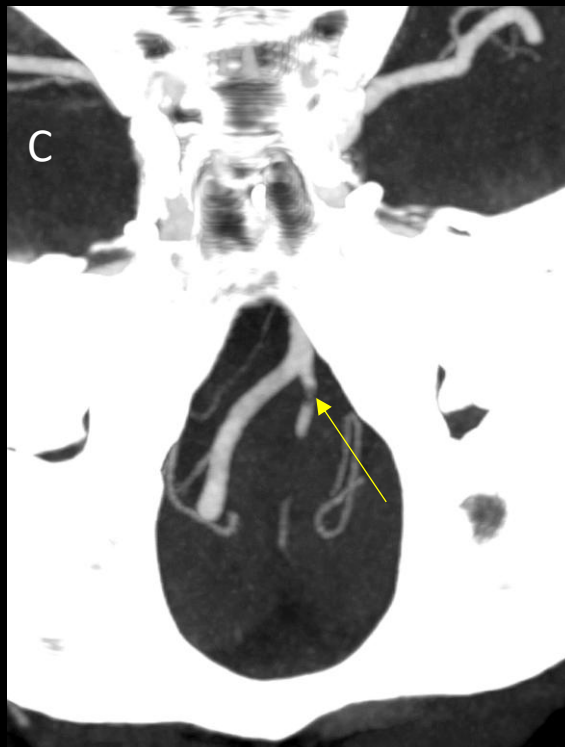
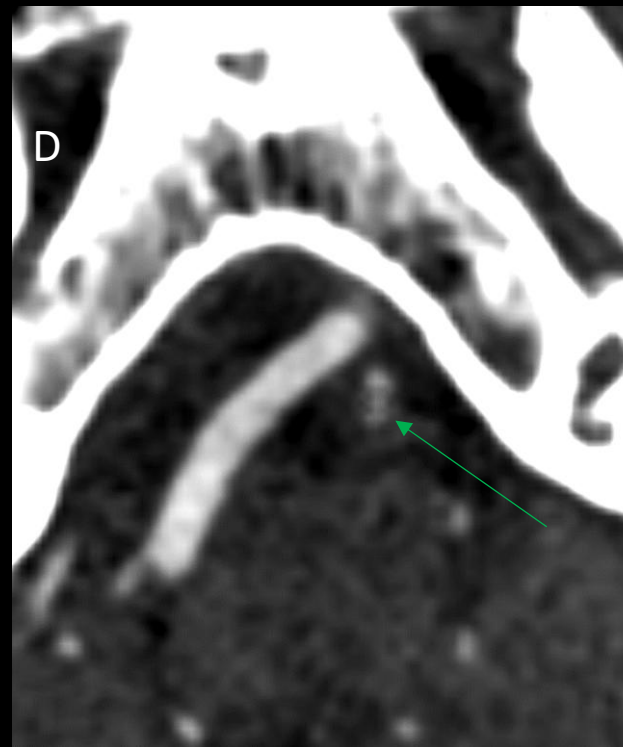
Companion case: Axial CT brain image (A) of a patient presenting with bilateral subdural hemorrhages (yellow arrows).

Apparent filling defect / narrowing in the distal left V4 segment in the coronal (B) and axial (C) MIP images (yellow arrows) of concurrent CTA for same patient. Target like appearance (green arrow) in zoomed up axial CTA images (D) with vertically oriented tram-track like appearance (blue arrow) in CTA sagittal reconstruction (E) which was suggestive of isocenter artifact.

- A catheter angiography can also be performed if necessary but can usually be avoided with a follow-up MRA or CTA.
- This artifact can be difficult to recognize if only a small portion of the structure overlies the artifact (as seen in the companion case). Close observation of thin section images for the target like appearance can be helpful in such cases. Knowledge of this artifact would help avoid misdiagnosis and unnecessary additional investigations.
